Technical Service Bulletin

07-006/17 - A/C BLOWS WARM AIR DUE TO REFRIGERANT LEAK

Bulletin No.: 07-006/17

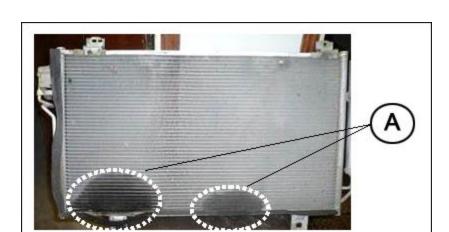
Condenser corrosion, causing a refrigerent leak (A).

1.Replace the condenser. Refer to MGSSonline Workshop Manual CONDENSER REMOVAL/INSTALLATION [SKYACTIV-G 2.0].

NOTE: When replacing the condenser, add compressor oil of approximately 40 ml [40 cc, 1.4 fl oz]. Refer to MGSSonline Workshop ManualREFRIGERANT CHARGING.

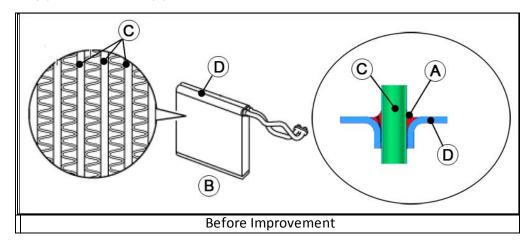
• Improper brazing (A) of the evaporator (B), causing a refrigerant leak from the joint between the tubes (C) and the header (D).

- 1.Replace the A/C evaporator. Refer to MGSSonline Workshop Manual:
 - CX-3 A/C UNIT REMOVAL/INSTALLATION.
 - Mazda2 A/C UNIT REMOVAL/INSTALLATION.

NOTE: When replacing the evaporator, add compressor oil of approximately 40 ml [40 cc, 1.4 fl oz]. Refer to MGSSonline Workshop Manual REFRIGERANT CHARGING.

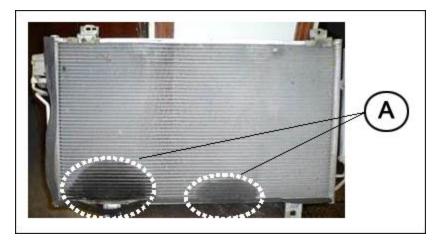
4. Visually inspect the condenser for A/C refrigerant leak. Is there a visible trace of A/C refrigerant leak at location (A)?

Yes - Go to A. Repair Procedure.

NOTE:Before proceeding to A. Repair Procedure, go to step 6. for a possible evaporator leak also.
